DDASaccident625

DDAS Accident Report

INCIDENT INVESTIGATION FOR [Demining group] – MINE ACTION TEAM - JORDAN

TASK NAME: JABIR 1 (477), NORTH BORDER PROJECT. EAST SECTOR

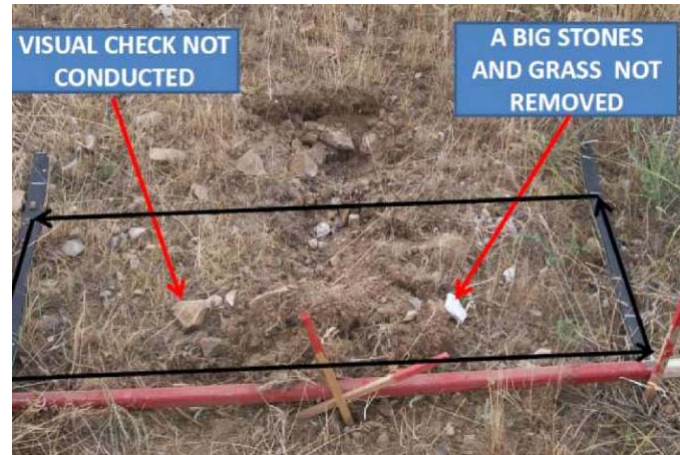
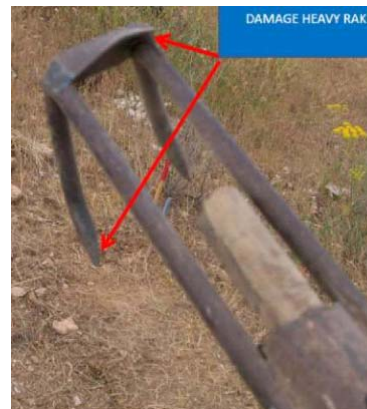
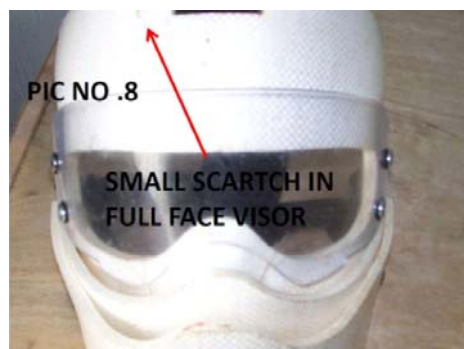
17. Comments (include measurements of any crater resulting from the explosion): Crater
Depth: approx. 18 cm / Width: approx. 30 cm

1. The deminer didn't use the light rake.
2. He didn't make the visual check because there were stones in the clearance box.
3. The deminer checked the signal out of the box and it was 70 cm from the base stick.
4. The base stick is in the right place.

5. He didn't do the right procedures in cutting grass and removing loose stones according to the SOP.
6. The area is hard with lots of stones which mean to be careful in using the heavy rake.
7. The depth of crater is 18 cm and the mine was on 13 cm depth.
8. He started progressing from the right side then he took it from the front which is wrong and caused a mine blast.
9. The heavy rake has been damaged because of the blast.
10. The marking sticks are put in the right place according to SOP.

1. The Deminer didn't follow the right drill before searching the mine.(visual check and clearing the loose stones in the clearance box).
2. The area is grassy and hard hence light rake is not effective.
3. He shouldn't check beyond 50 cm from the base stick (one clearance box) but he extended the search up to 70cm.
4. The mine blast incident occurred due to the individual mistake of doing wrong drills.

It is strongly recommended to issue a written warning to the deminer for not following the right procedure and drill which resulted in the mine blast incident.
